# Conversion of Traditional Farmer's House to the Urban-Rural Exchange Facility in Mountainous Region

-A case study on the local organization named "Kiwanosato-ni-tsudoukai"-

Sachiko Yamamoto<sup>1</sup>, Mahito Nakazono<sup>2</sup>

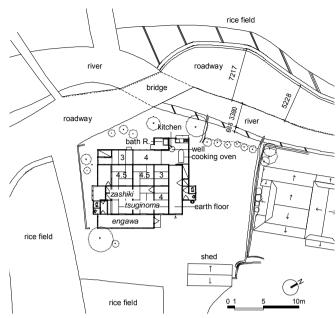
Figure.4 Layout and existing floor plan of O-house

O house was the thatched roof house built over 100 years ago (Figure.3). Figure.4 shows a existing plan. This house is a traditional farm house. There are four rooms(*Zashiki* and *tsuginoma*, etc.) and four small rooms(under 4-tatami room). This house is a traditional farm house. There are four rooms(*Zashiki* and *tsuginoma*, etc.),four small rooms(under 4-tatami room), a well and an oven(*Kamado*)(Figutr.5,6).

Nakazono laboratory of Yamaguchi University investigated O-house during September to November in 2008. It found that the west side of the house slanted as a result of measuring the inclination of pillars and beams. Because the ground was loose along with a river to flow on the west side, the ground subsidence was caused and O-house slanted.

Because deterioration and corrosion of the west side were remarkable by the result of the investigation, it was judged that five of the next were necessary. 1) Repairing the inclination of pillars and beams and reinforcing joint parts by hardware as structure reinforcement. 2) Exchanging rotted pillars and materials below the floor. 3) Improving the facility of the kitchen and the bathroom. 4) Changing the floor plan to make a multipurpose hall. 5) Repairing the interior such as changing floor carpet, wall paper, window and door.
